PROFIL LONGITUDINAL

BENEFICIAR:	
 C.N.A.I.R. S.A. BUCURESTI DIRECTIA REGIONALA DE DRUMURI SI PODURI IASI	
PROIECTANT:	
S.C. POD-PROIECT S.R.L. Iasi, str. Plopii fara sot nr. 3 Romania, jud. Iasi RO 14447212 www.pod-proiect.ro	
DENUMIRE PROIECT:	
REPARATII CURENTE POD PE DN 12A, KM 85+300	
FAZA: P.Th. + D.D.E. + C.S.	
SEF PROIECT	
ing. Marius GHEBAC	
DESENAT	
ing. Marius GHEBAC	
VERIFICAT INTERN	
ing. Ilie-Bogdan HRITCU	
DENUMIRE PLANSA	
PROFIL LONGITUDINAL	
Contract nr. 177 din 01.07.2019	
Revizia nr.:	rev.01
Scara:	1:500
Data:	2019
Nr. Plansa	Cod15/ Pth/ - 03

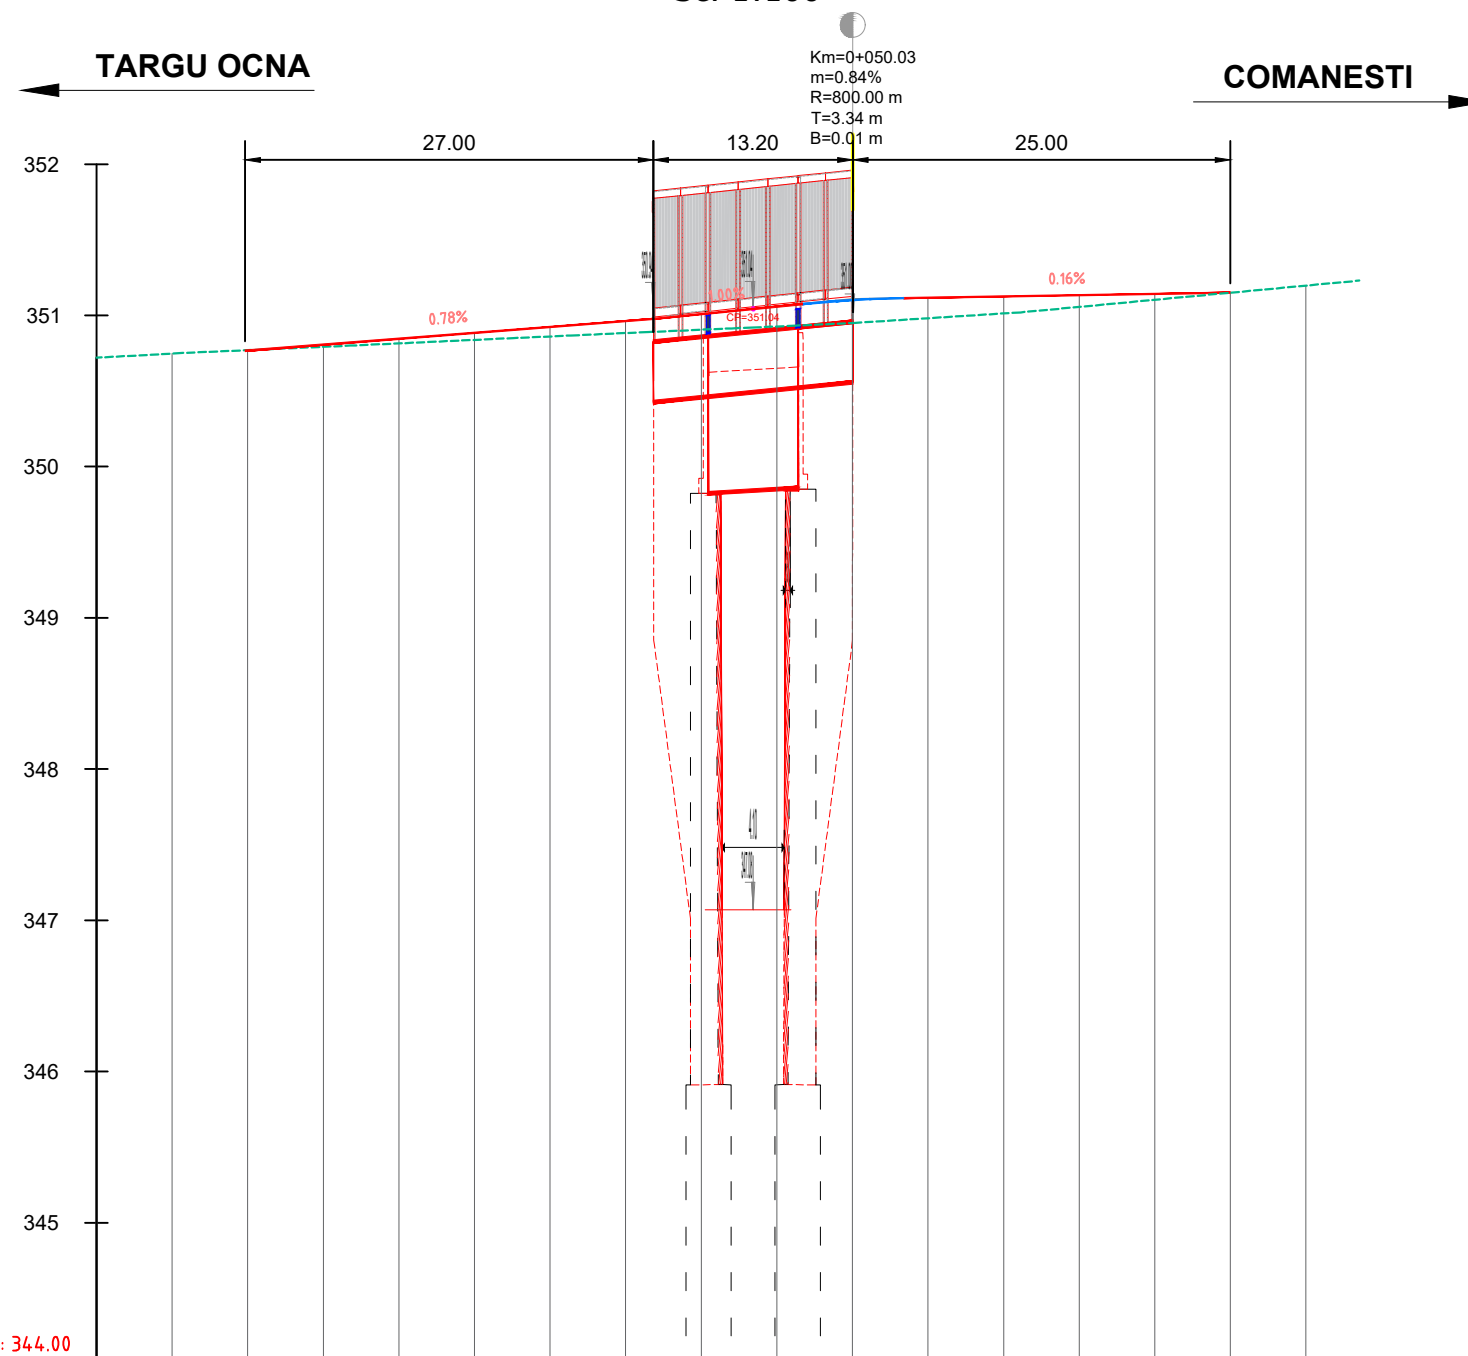
PICHETI	P 1	P 2	P 3	P 4	P 5	P 6	P 7	P 8	P 9	P 10	P 11	P 12	P 13	P 14	P 15	P 16
DIFERENTE IN AXA (cm)		0	+1	+3	+5	+6	+8	+10	+13	+15	+14	+11	+8	+4	0	
COTE PROIECT		350.77	350.81	350.85	350.88	350.92	350.96	351.01	351.06	351.10	351.12	351.13	351.13	351.14	351.15	
COTE TEREN	350.75	350.77	350.79	350.81	350.84	350.86	350.88	350.91	350.93	350.95	350.98	351.01	351.06	351.10	351.15	351.23
RACORDARI VERTICALE	<div> <div>L=27.00 P=0.8%</div> <div>L=9.86 P=1.0%</div> <div>R=800.00m L=6.68m</div> <div>L=21.63 P=0.2%</div> </div>															
DISTANTE INTRE PICHETI	5.00	5.00	5.00	5.00	5.00	5.00	5.00	5.00	5.00	5.00	5.00	5.00	5.00	5.00	5.00	3.53
ALINIAMENTE SI CURBE	<div> <div>Al=46.26 m</div> <div>Al=14.87 m</div> <div>Al=22.40 m</div> </div>
